**BARTLETT'S FISHING LAKE DAM
STODDARD COUNTY, MISSOURI
MO 40046**

PHASE 1 INSPECTION REPORT

⑥ NATIONAL DAM SAFETY PROGRAM

Name of Dam: Bartlett's Fishing Lake Dam
State Located: Missouri
County Located: Stoddard
Stream: Tributary of Dudley Main Ditch
Date of Inspection: 5 December 1980

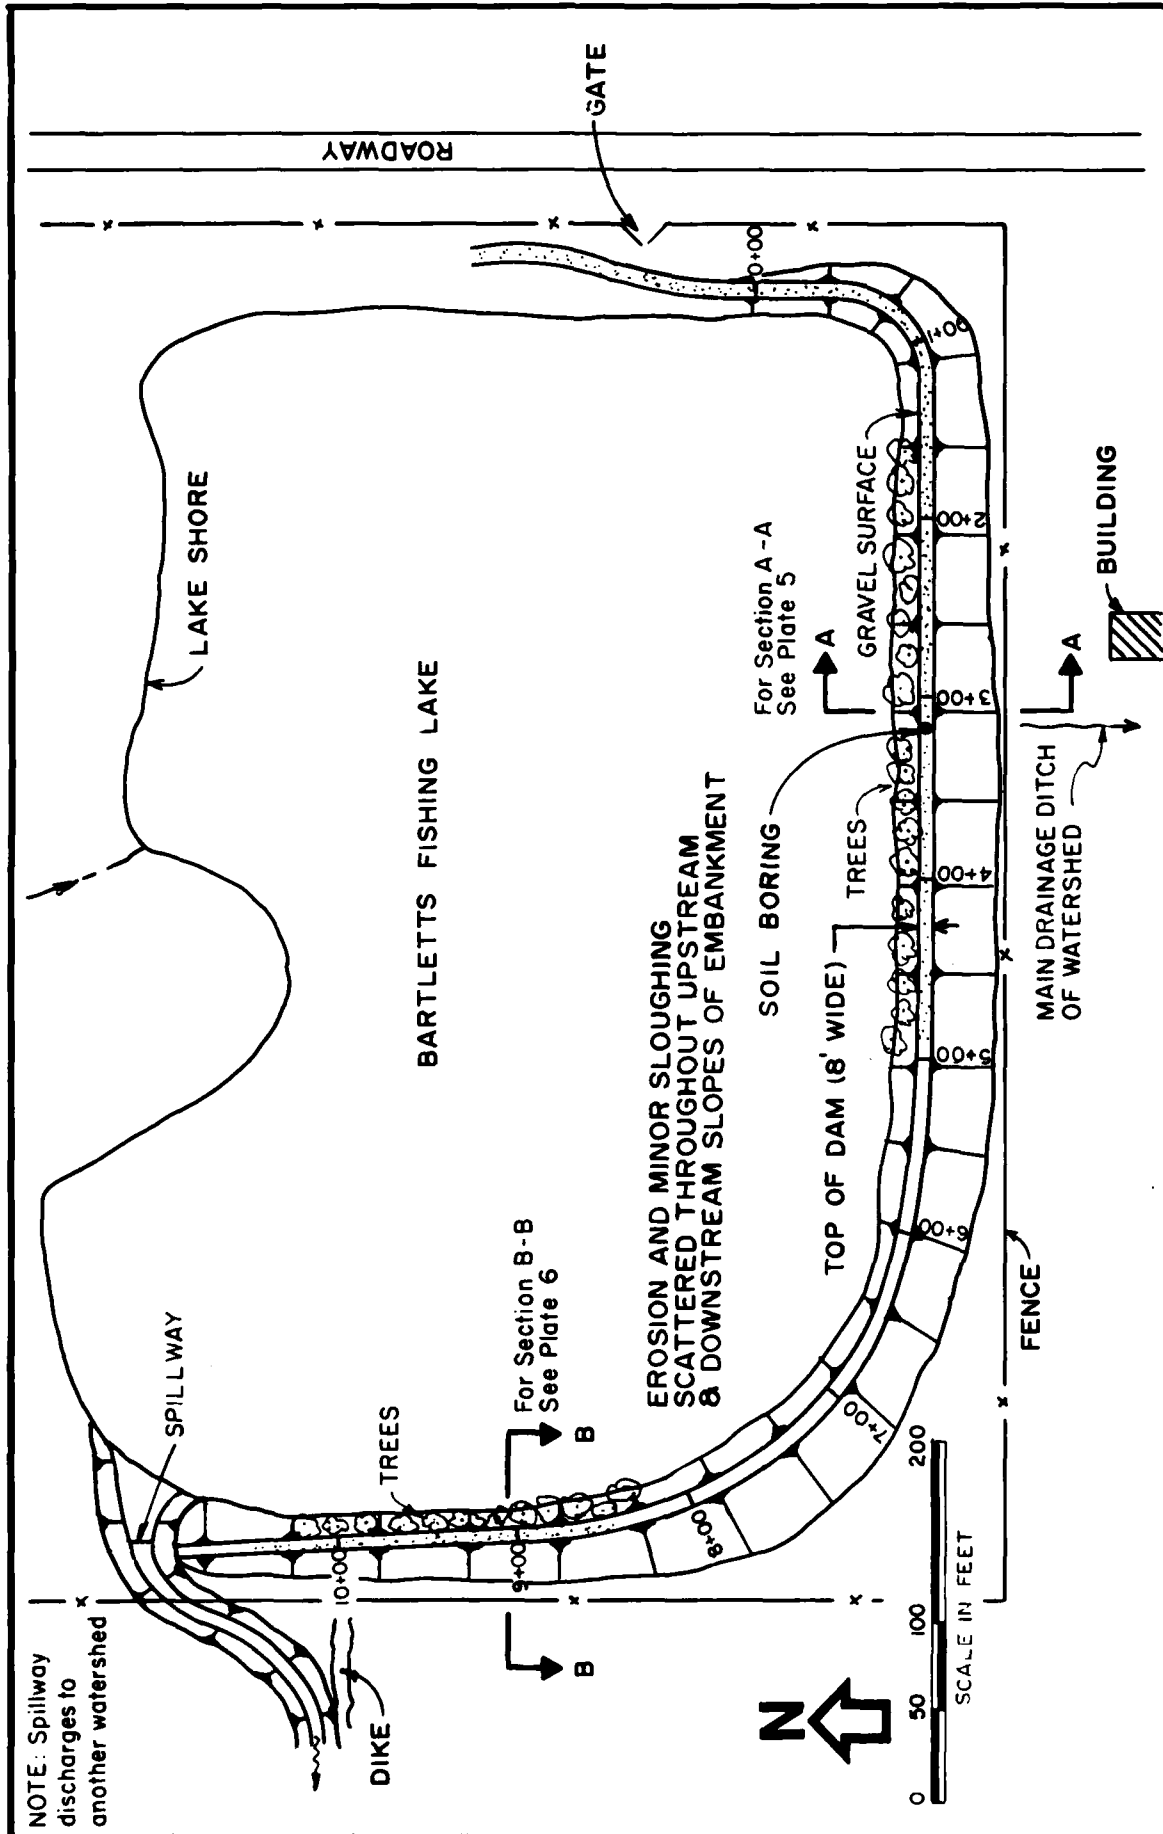
PLAN OF DAM AND SPILLWAY BARTLETT'S FISHING LAKE DAM MO40046

The embankment appears to be in poor condition. Both the horizontal and vertical alignment of the crest of the dam are non-uniform. The embankment bends at each abutment form a "U" shape (see Plate 4 of Appendix A). The non-uniformity of the horizontal alignment is due to the fact that these bends are not smooth curves. The non-uniform alignment appeared to be the result of the original construction. The vertical alignment varies from an elevation of approximately 412.4 feet at the right abutment to 415.8 feet approximately 50 feet away from the lowest point (see Exhibit 3 of Appendix B). The variation in the elevation of the top of the dam appeared to be the result of original construction or the additional fill added in 1979.

The flow line of the spillway channel is non-uniform in slope (see Exhibit 5 of Appendix B). Since there is sparse vegetal cover in the channel, some erosion can be expected when there is flow through the spillway. Most of the erosion would occur where the slopes are steepest. Such erosion would likely not cause a breach of the dam. The spillway does not discharge into the main watershed drainage channel (see Plate 4).
